Watershed Restoration FACTSHEET:

Turkey Branch Project

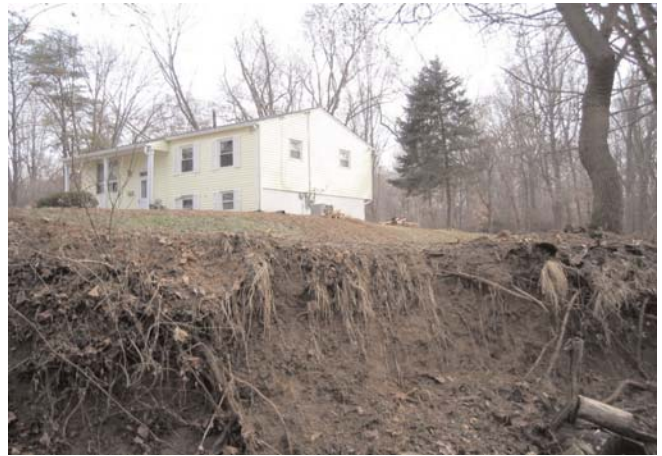
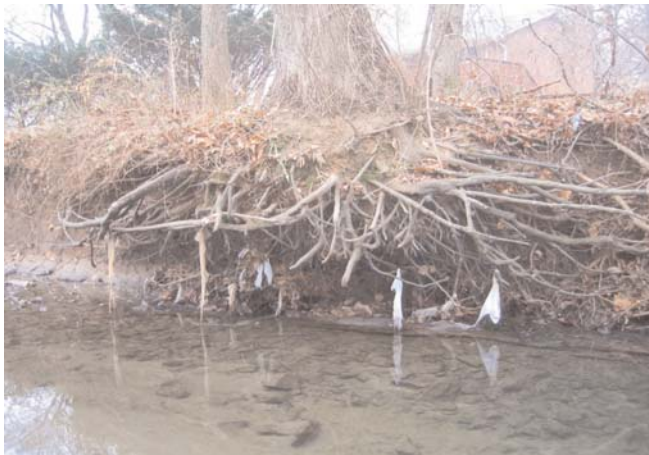
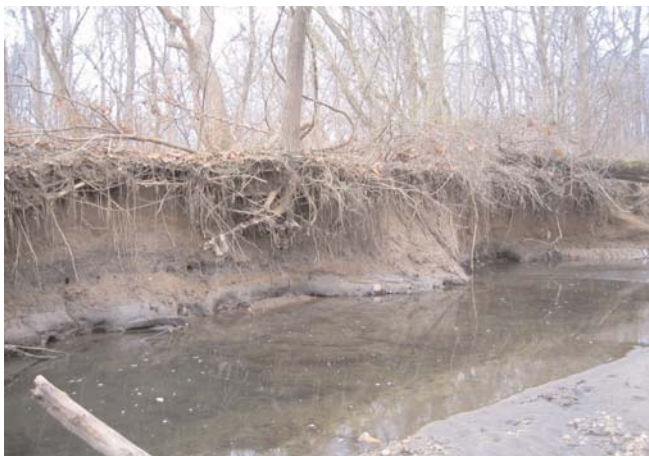
The eroding stream banks of Turkey Branch are threatening the stream-side vegetation, including large rooted trees (above).

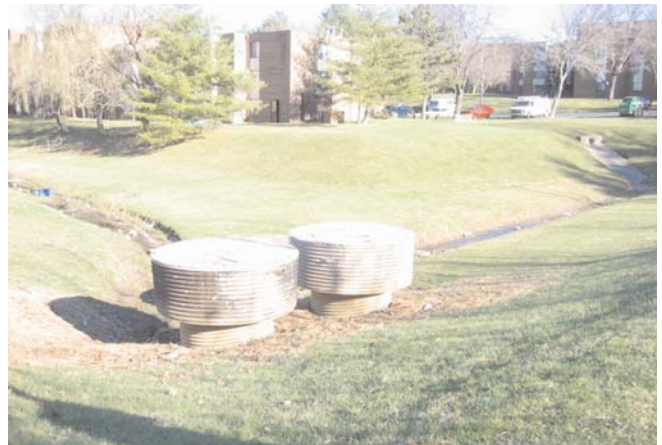
The upper photo depicts Turkey Branch streambank eroding away due to high uncontrolled stormwater. The lower photo is the Peppertree Stormwater pond prior to the planned retrofit which will improve water quality.
